SUP 118/25

MADRID/Adolfo Suárez Madrid-Barajas AD (LEMD).- Demolition of regulator chambers – Ramp 0.

Until 10 July 2026 (estimated), works to demolish the regulator chamber on the remote apron Ramp 0 and the resurfacing of the apron until TWY M11 will be performed in the airfield at Adolfo Suárez Madrid-Barajas Airport.

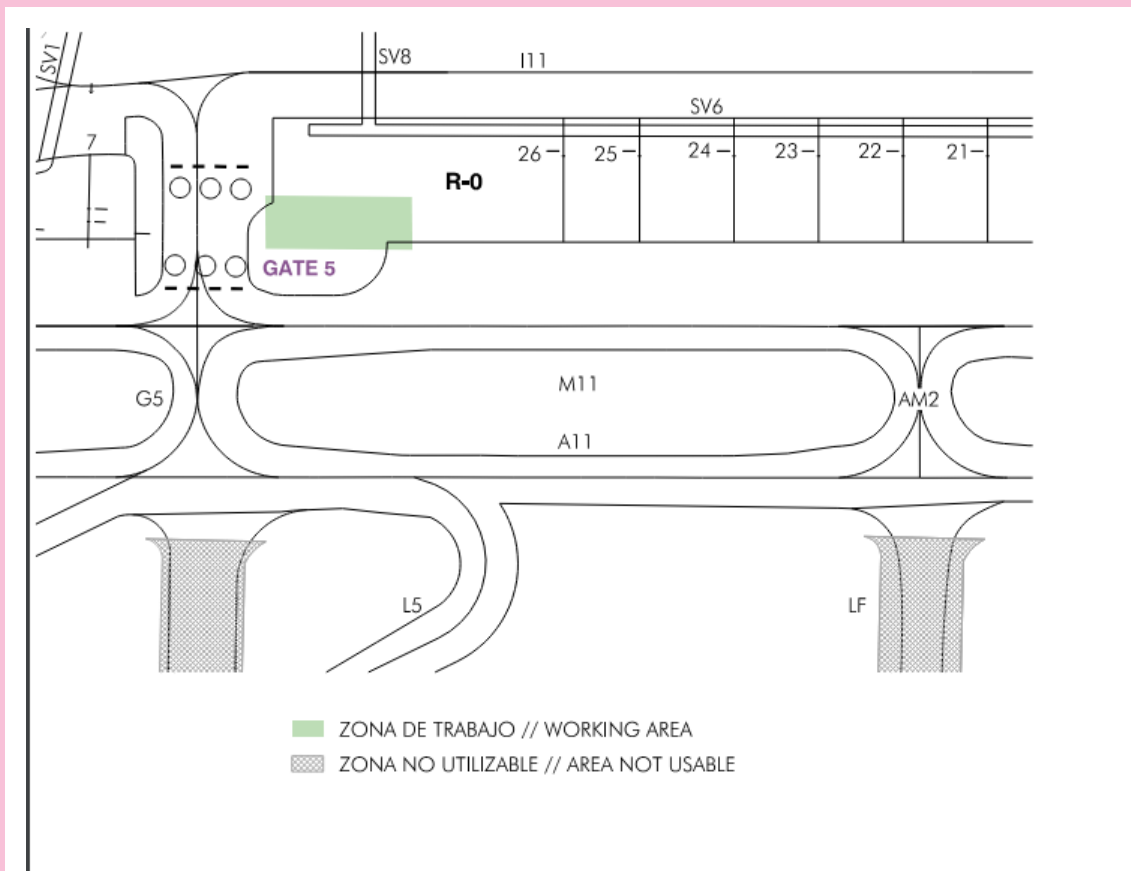
Phase 1 Work zones

Description of the phase: Works at 40 metres from TWY M11 to demolish the chamber CR 14R BIS and building new access to the gallery.

- TWY M11 limited to maximum code letter E aircraft.
- Aircraft taxiing on TWY M11 must do so at low speeds and exercise extreme caution, due to their proximity to the work zone.

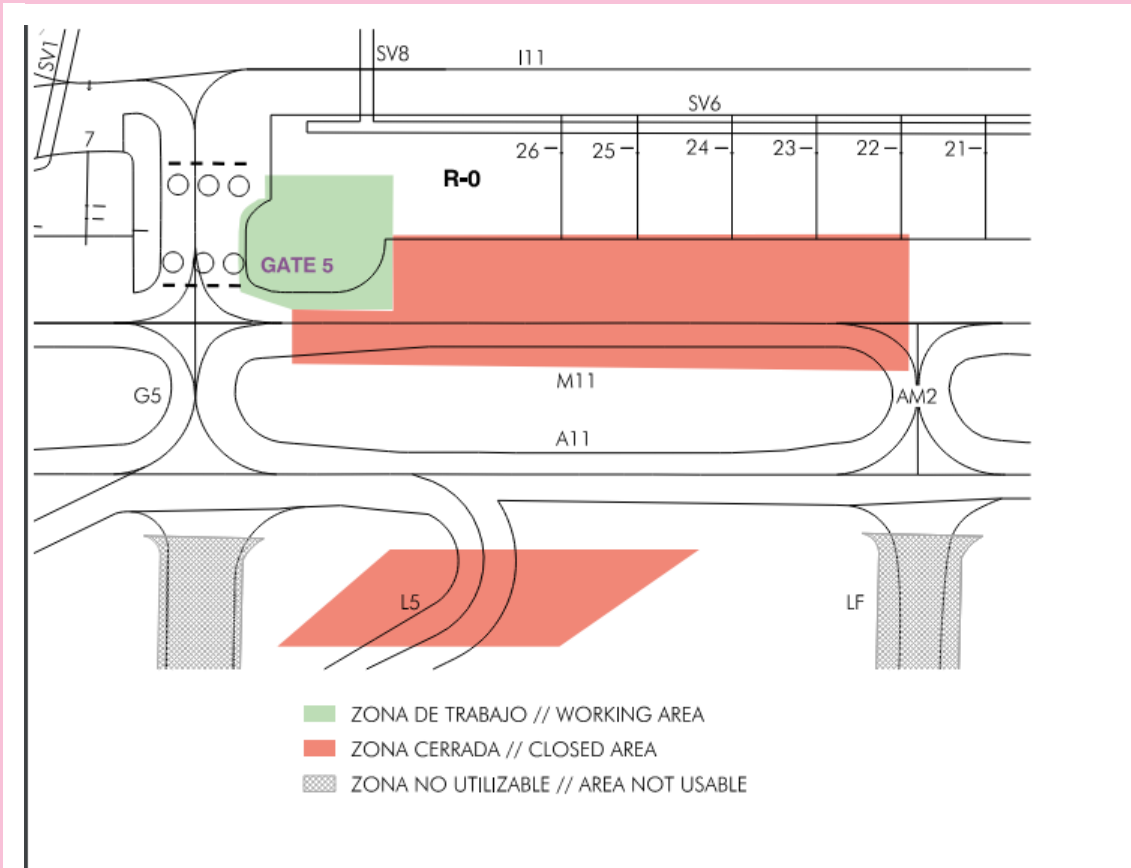
Phase 2A. Work zones

Description of the phase: Demolition works and resurfacing between TWY M11 and the apron Ramp 0.

- Rapid exit TWY L5: closed
- TWY M11, section between TWY AM2 and GATE 5: closed, (M11 only usable for access to PRKG 20 and 21)
- GATE 5 limited to maximumcode letter C aircraft.
- TWY A11, G5 and G6 bi-directional use.
- PRKG22 to 26: closed.

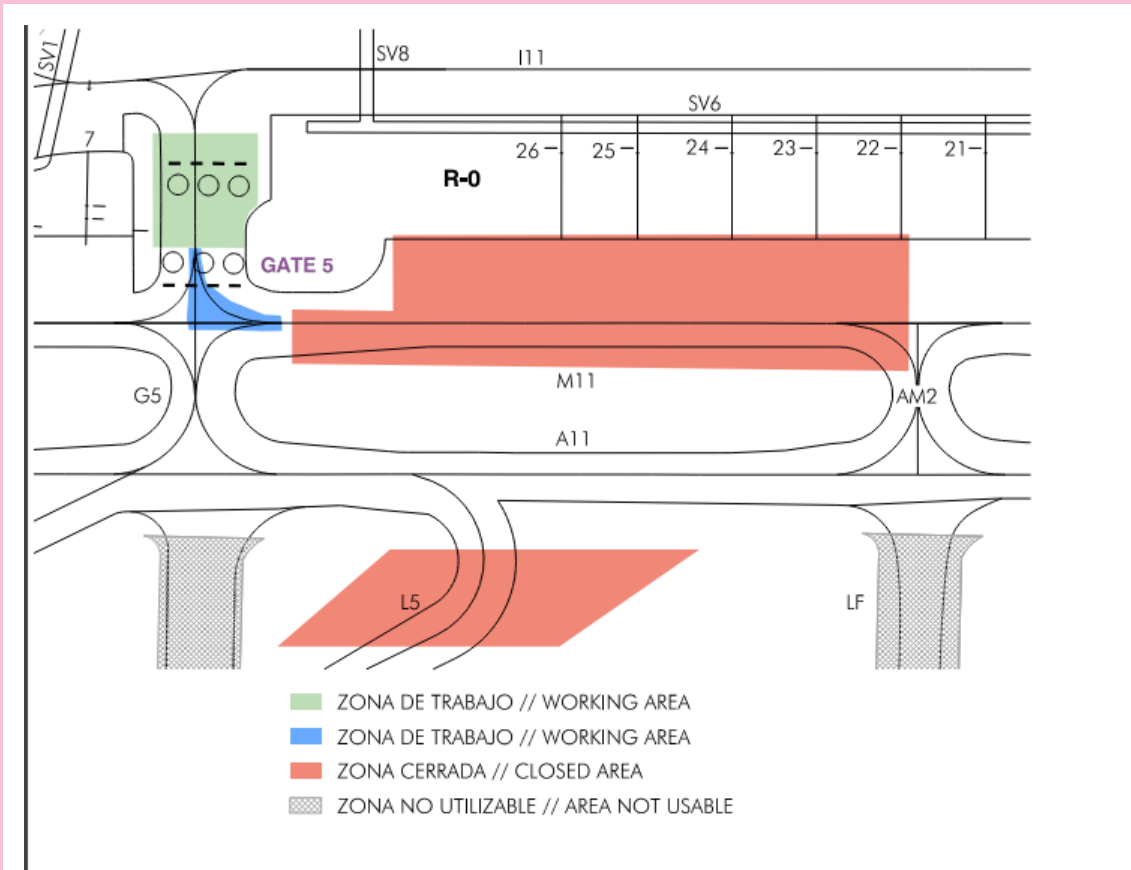
Phase 2B. Work zones.

Description of the phase: Lighting works at GATE 5 and at crossing M10-G5-M11-GATE 5. To be activated within the activation period of Phase 2A, coinciding with it.

- TWY GATE 5: closed (24H).
- Crossing TWY M10-G5-M11-GATE 5: closed only occasionally at night time from 23:00 to 07:00 LT;

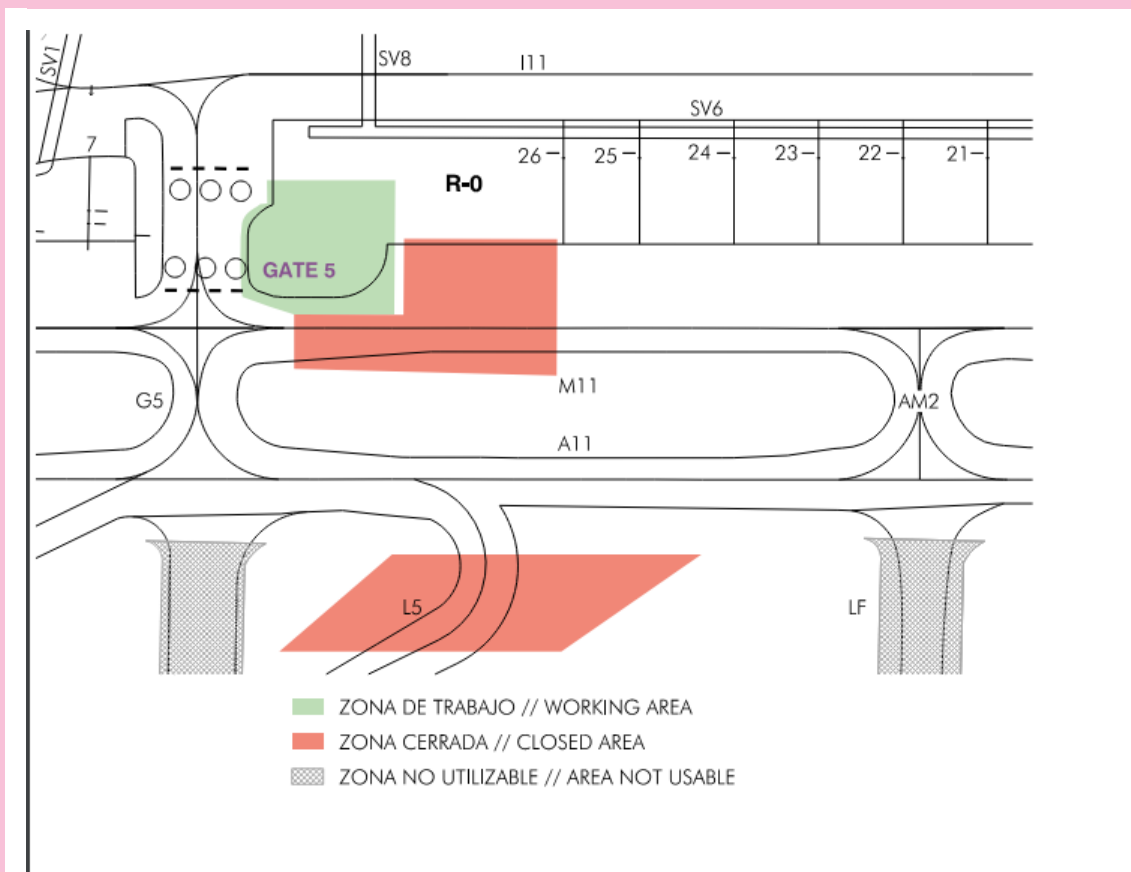
Phase 3A. Work zones.

Description of the phase: Demolition works and resurfacing between M11 and the apron Ramp 0.

- Rapid exit TWY L5: section between RWY and TWY A11 closed.
- TWY M11, section between PRKG 26 and GATE 5: closed.
- GATE 5 limited to maximum code letter C aircraft.
- TWY A11, G5 and section of TWY L5 between M11 and A11: bi-directional use.
- PRKG 26: closed.
